Hilti CFS-C EL Firestop Collar Endless

Submission Folder

FIRE RESISTANCE TEST IN ACCORDANCE WITH BS 476: PART 20: 1987
On 6 nos. of PVC Pipes and Conduits (Specimens '20', '22', '23', '24', '25' and '26')

Test Report No.: R16L28-1C

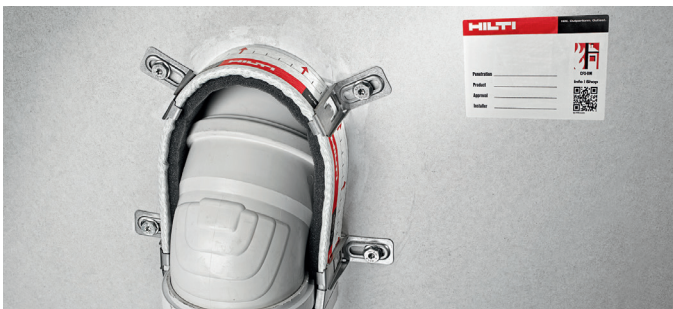
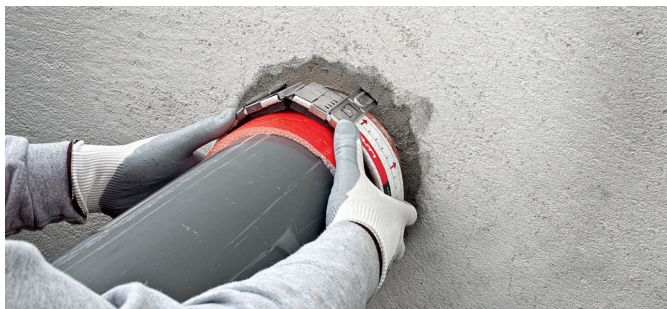
APPLICATIONS

- Suitable for use on shaft walls, coated board, drywall, aerated concrete, masonry and concrete
- Zero distance required to CFS-C EL firestop endless collar
- Approved for use with PVC, PP, PE and a wide array of standard acoustic pipes.
- Configurations tested include pipe elbows, inclined pipes and pipes with limited clearance to the wall
- Acoustic pipes tested with insulation and sound decoupling

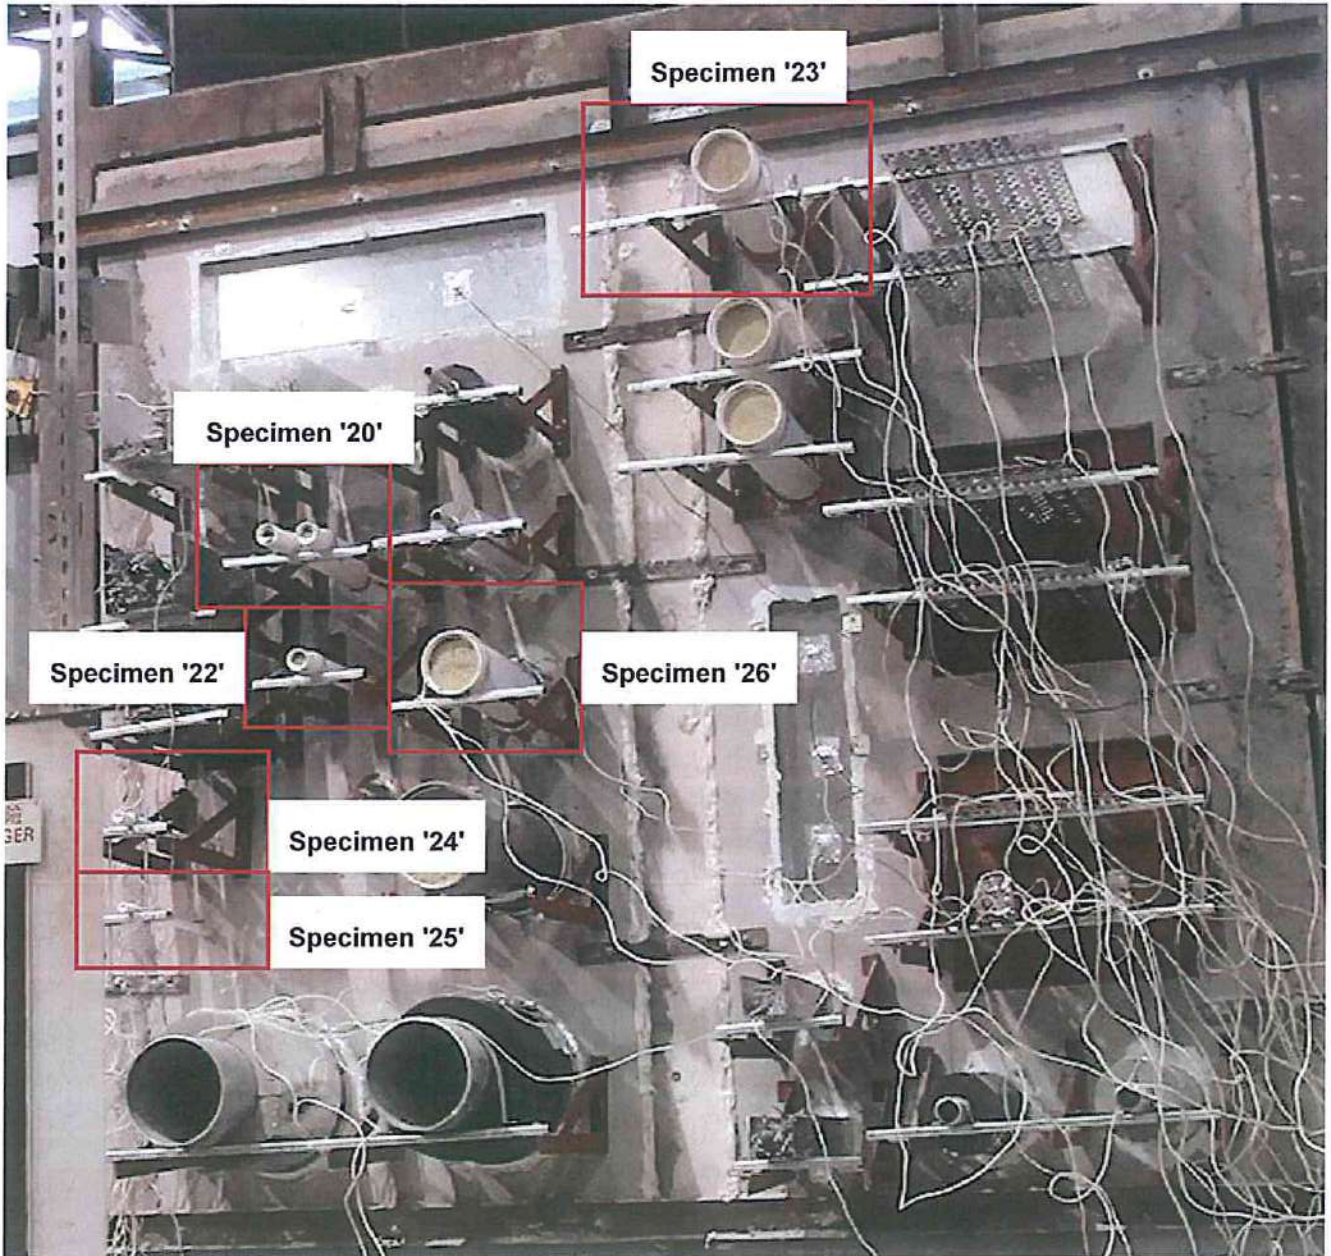
Photo 1: The unexposed face of the specimens before the test.

Note: In this test report, only specimens '20', '22', '23', '24', '25' and '26' were considered.

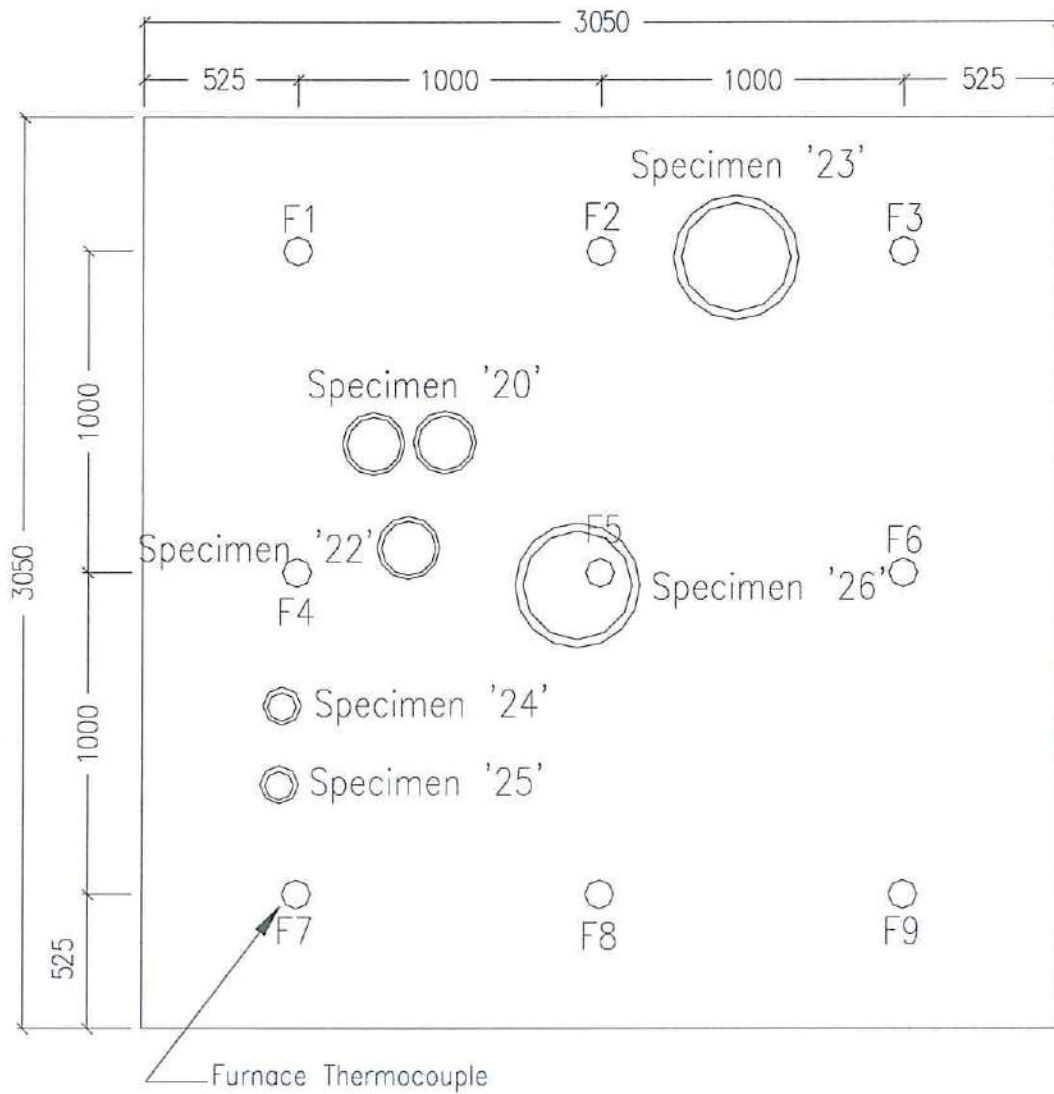
Figure 1 – Locations and reference numbers of furnace thermocouples.
(This figure is not to scale and all dimensions are in millimetres.)

Nine (9) 'type K' thermocouples to monitor the temperature of the furnace, which were kept at 100 mm from the exposed face of the specimen (see Figure 1).

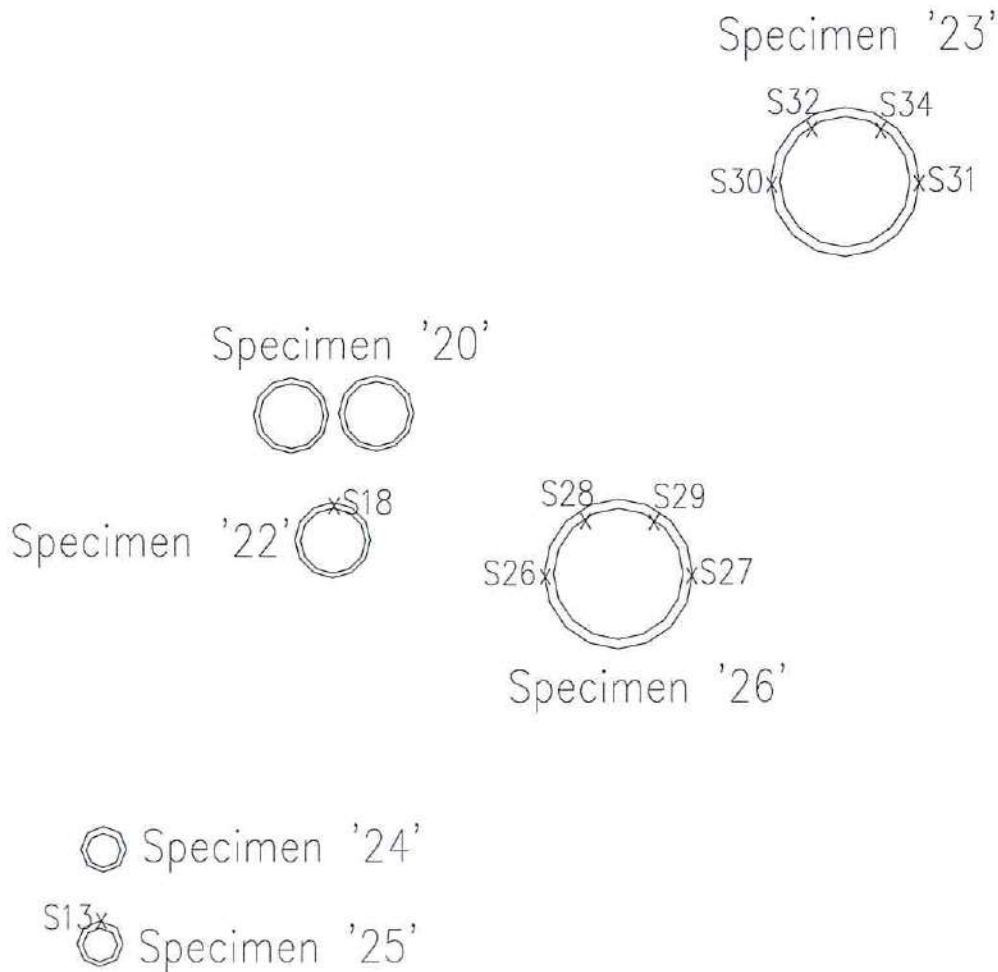
Figure 2 – Locations and reference number of thermocouples to monitor the temperature of unexposed surface of the specimens.

*Note: Thermocouples S26, S27, S30 and S31 were fixed at 50 mm away from the concrete wall.
Thermocouples S28, S29, S32 and S34 were fixed at 100 mm away from the concrete wall.
Thermocouples S18 and S13 was fixed for additional information only.*

Ten (10) 'type K' thermocouples to monitor the temperature of the unexposed face of the specimens (see Figure 2).

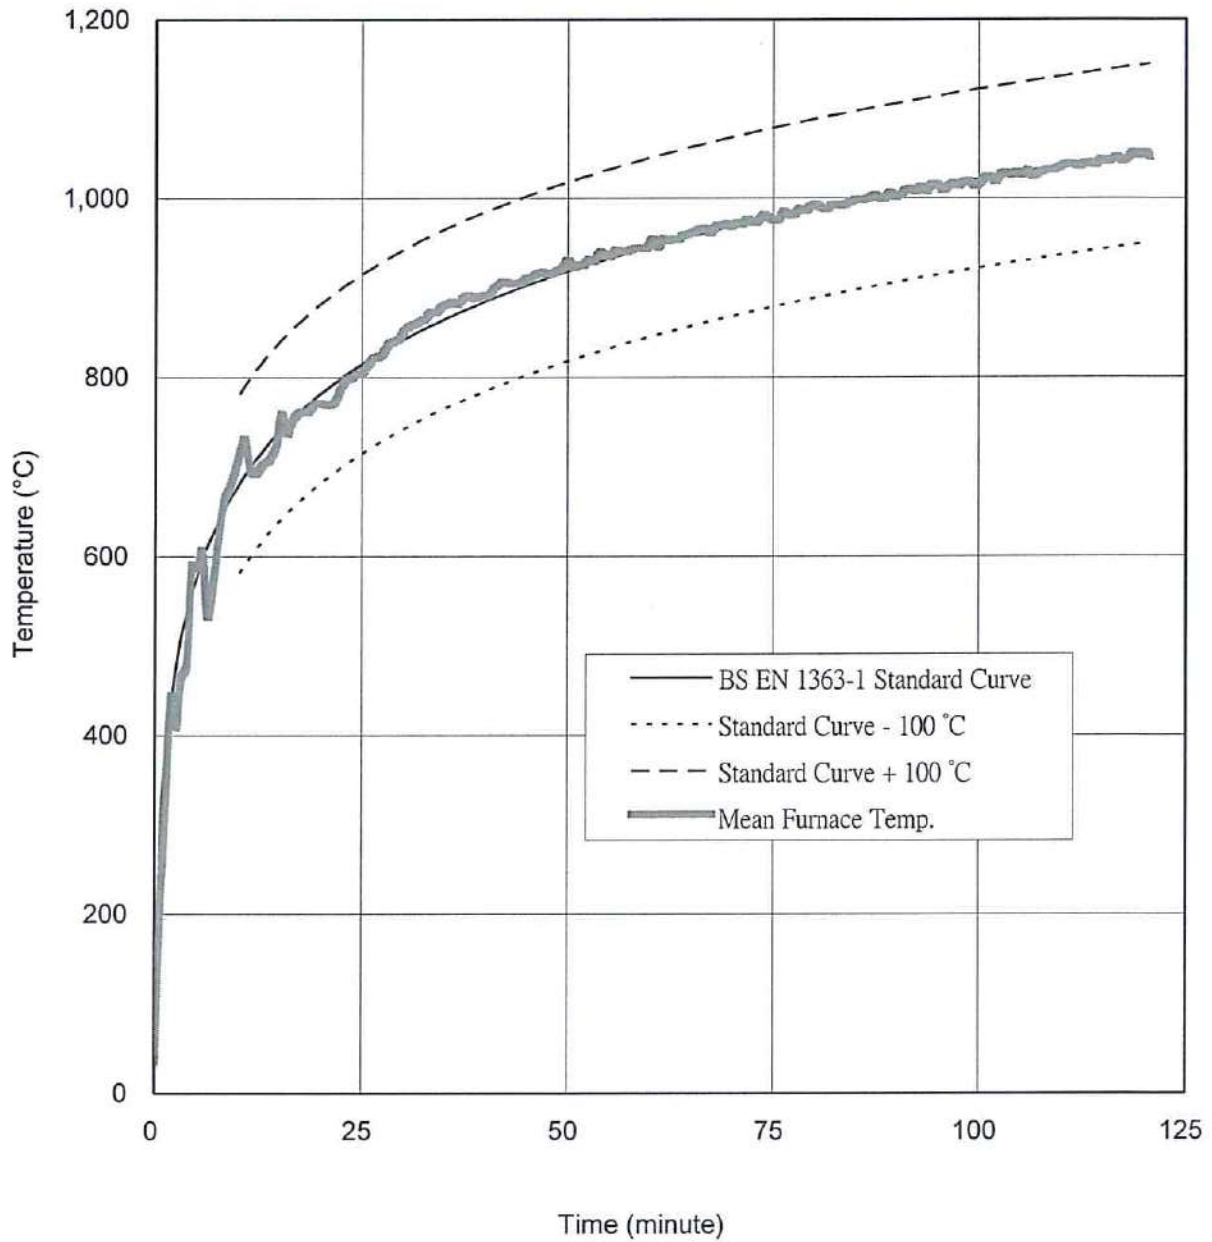
Figure 3 – Mean furnace temperature.

The furnace was monitored by nine (9) thermocouples so that the mean furnace temperature complied with the requirements of Clause 3.1 of BS 476: Part 20: 1987.

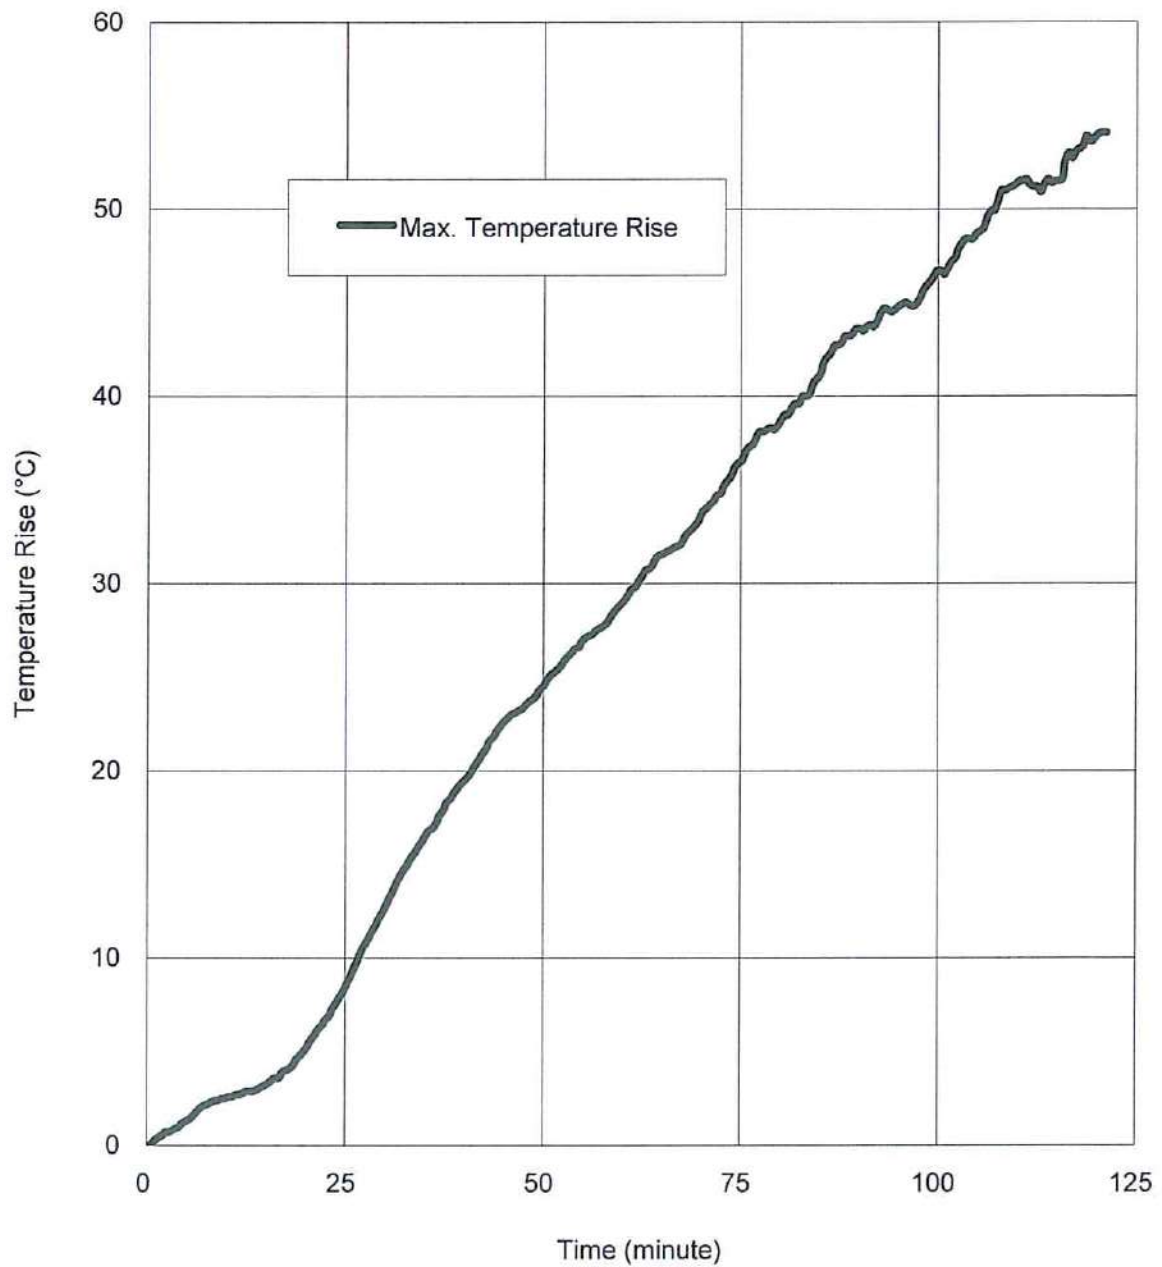
Figure 4 – Temperature rises of unexposed surface of specimen '22' (for additional information only).

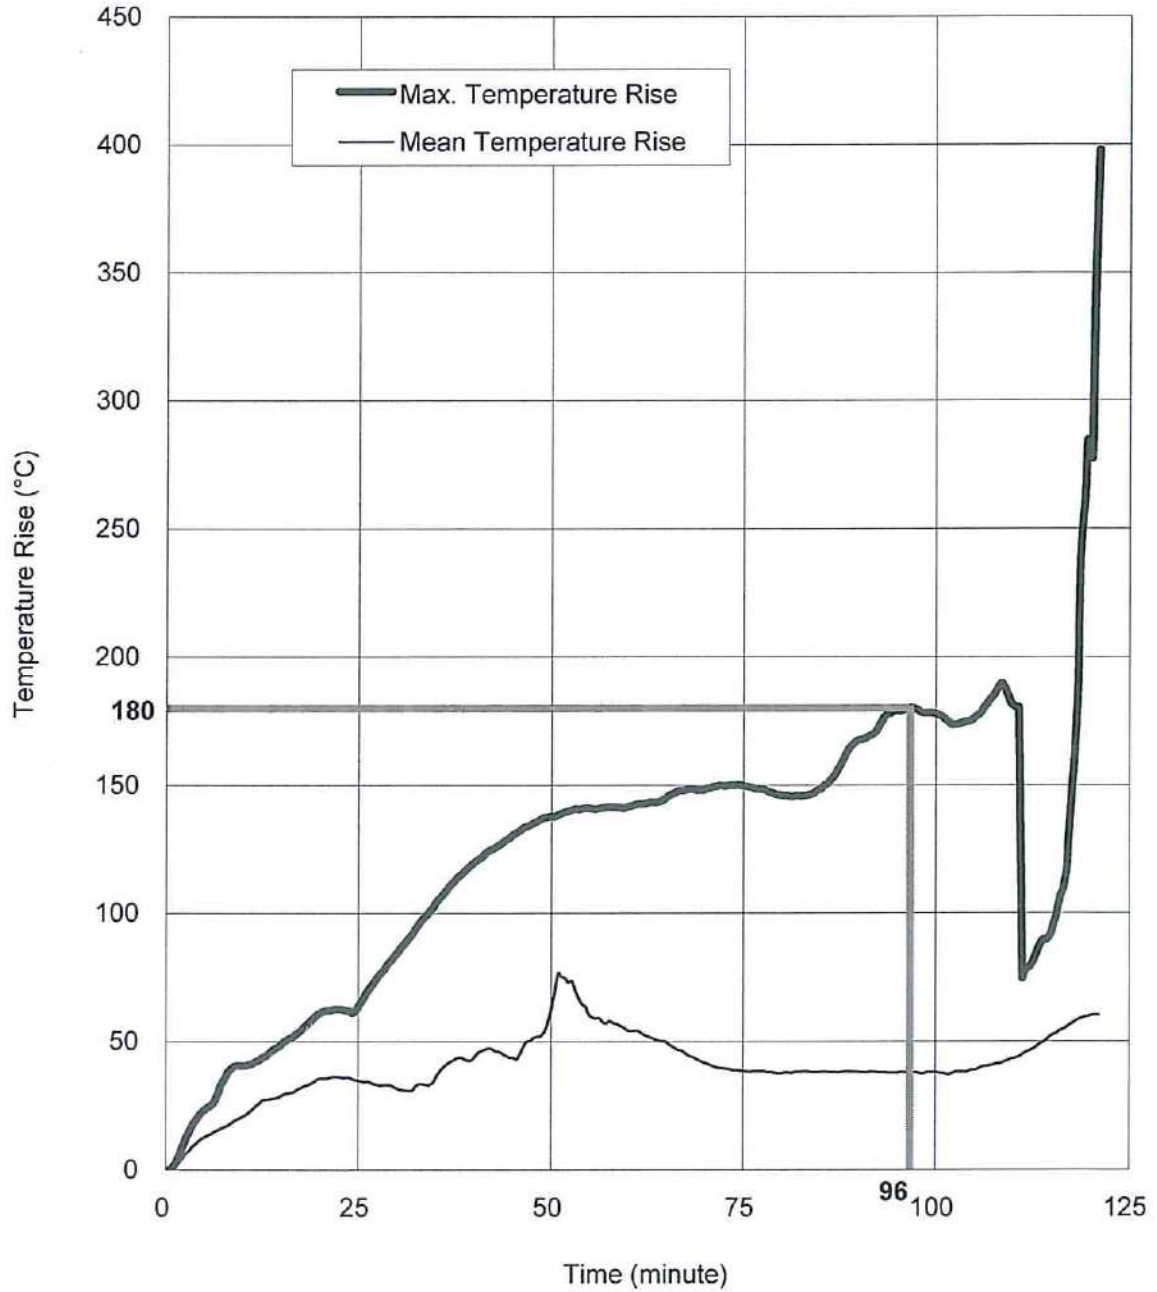
Figure 5 – Temperature rises of unexposed surface of specimen '23'.

Note: Thermocouple S30 detached after a heating period of 111 minutes.

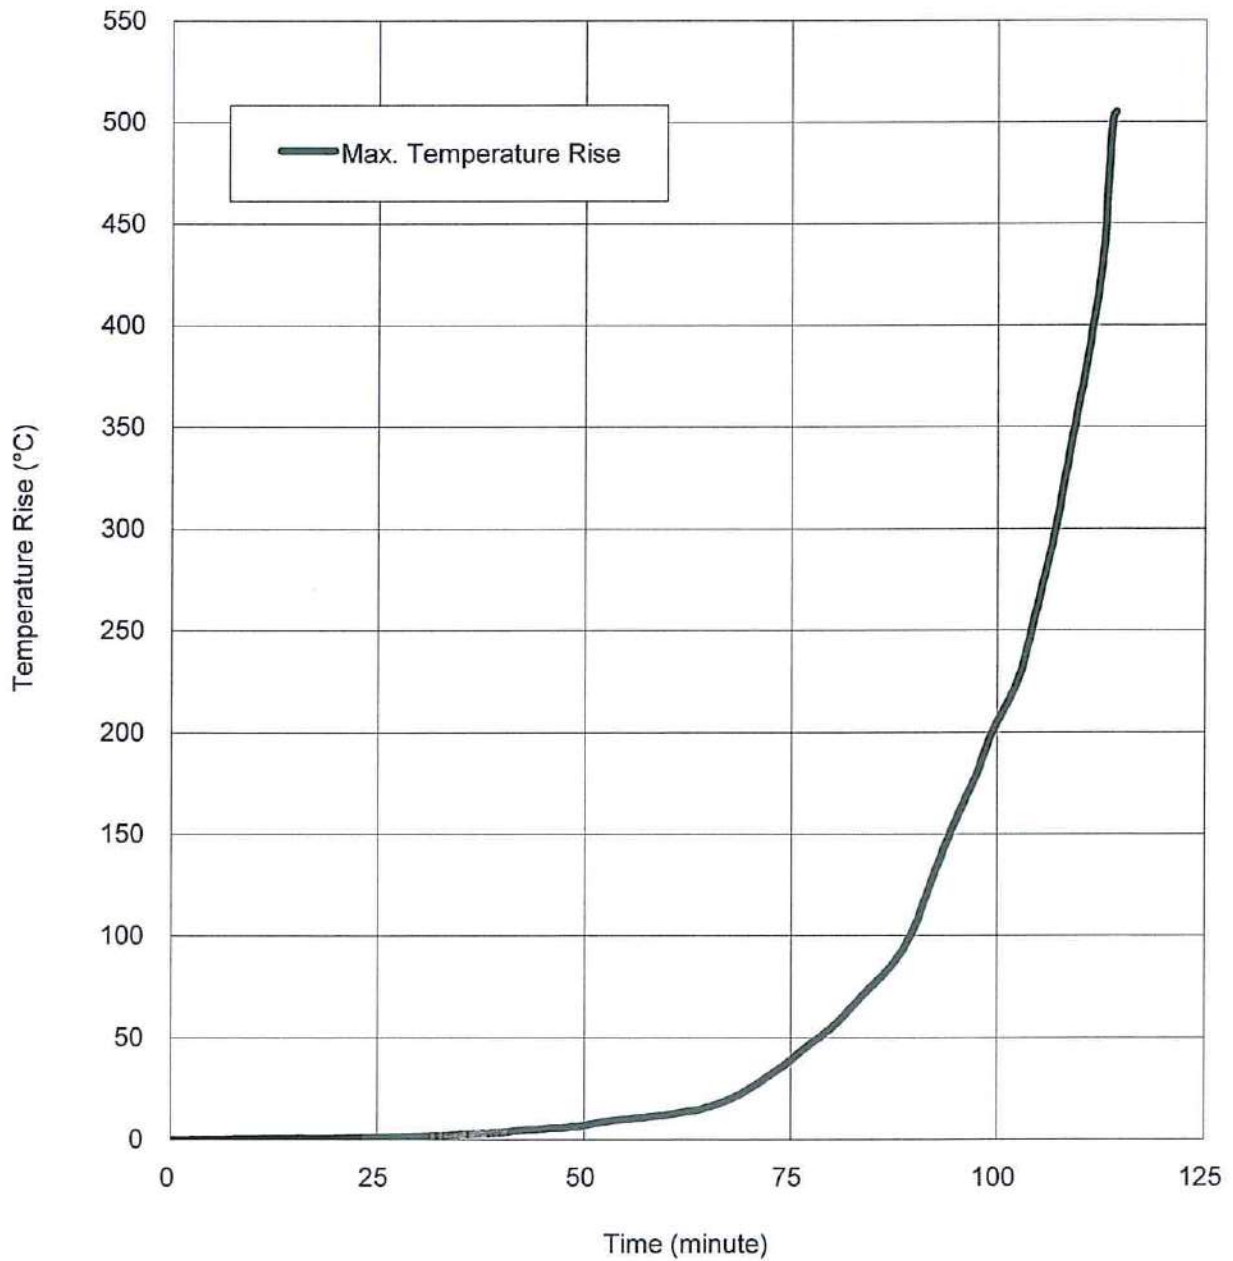
Figure 6 – Temperature rises of unexposed surface of specimen '25' (for additional information only).

Note: Thermocouple S13 was detached after a heating period of 114 minutes.

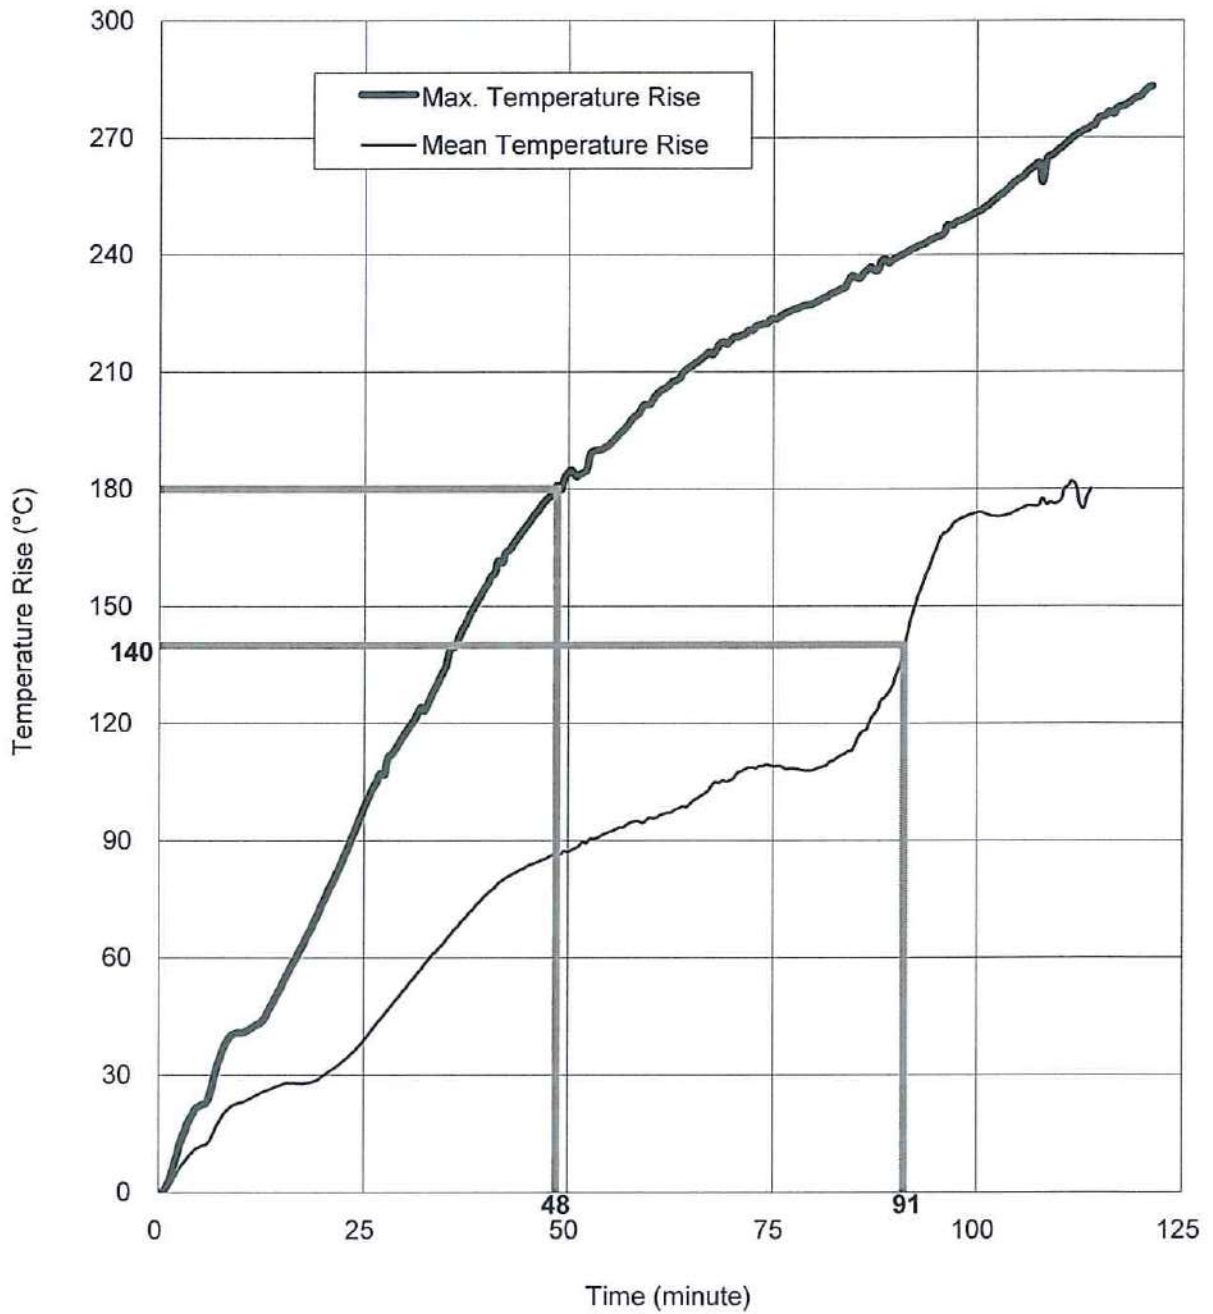
Figure 7 – Temperature rises of unexposed surface of specimen '26'.

Note: Thermocouples S27-S29 were detached after a heating period of 114 minutes.

Specimen '26' was comprised of 1 no. of 150 mm internal diameter by nominal 5 mm thick by 1,400 mm long PVC pipe filled with a layer of 20 mm thick 'ROCKWOOL' mineral wool boards with density of 100 kg/m³ with and 'Hilti CP606' sealant. The pipe was protected by 2 stacks of 'CFS-C EL' firestop endless collars.

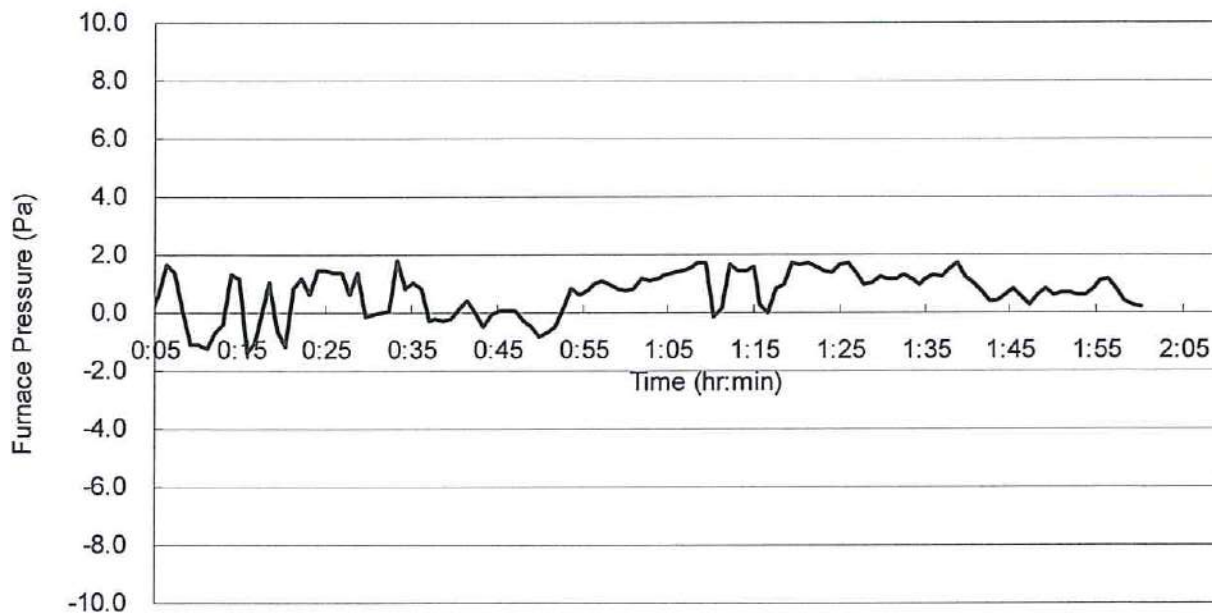
After the first 5 minutes of the test, the furnace pressure was maintained at 0 ± 2 Pa relative to atmosphere, at 1,000 mm from the notional floor level.

Figure 8 – Furnace pressure.

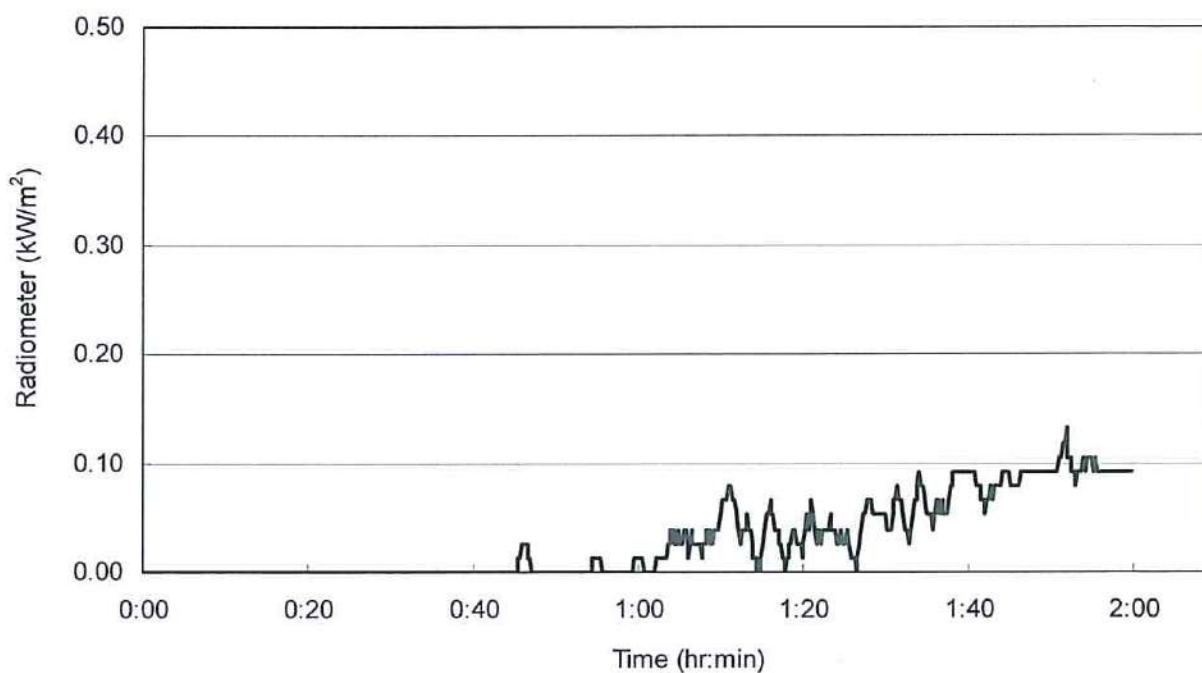
A radiometer placed at 1,000 mm away from the unexposed surface to measure the radiation of unexposed surface of the specimens.

Figure 9 – Radiation.

A radiometer placed at 1,000 mm away from the unexposed surface to measure the radiation of unexposed surface of the specimens.

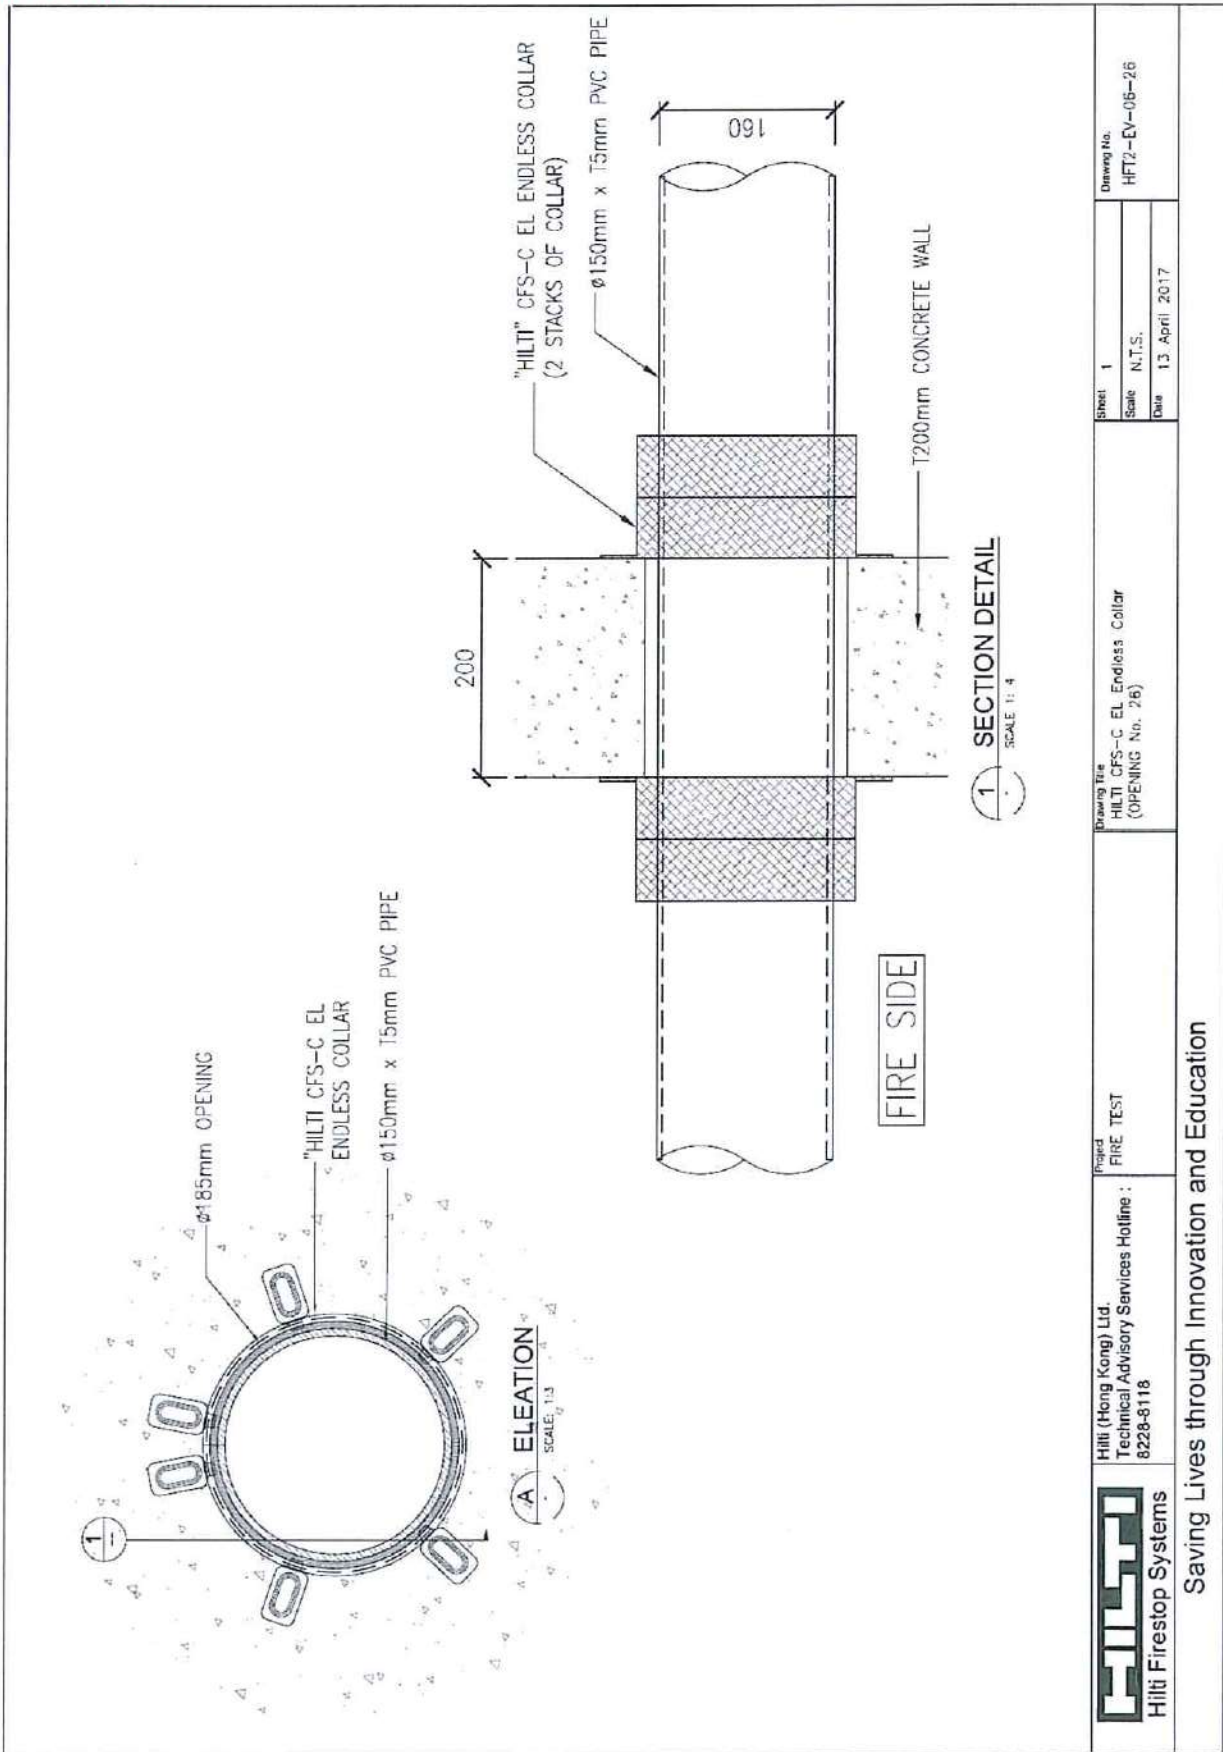
Hilti Firestop Systems	Hilti (Hong Kong) Ltd. Technical Advisory Services Hotline : 8228-8118	Project FIRE TEST	Drawing Title HILTI CFS-C EL Endless Collar (OPENING No. 26)	Sheet 1 Scale N.T.S. Date 13 April 2017	Drawing No. HFT2-EV-05-26
		Saving Lives through Innovation and Education

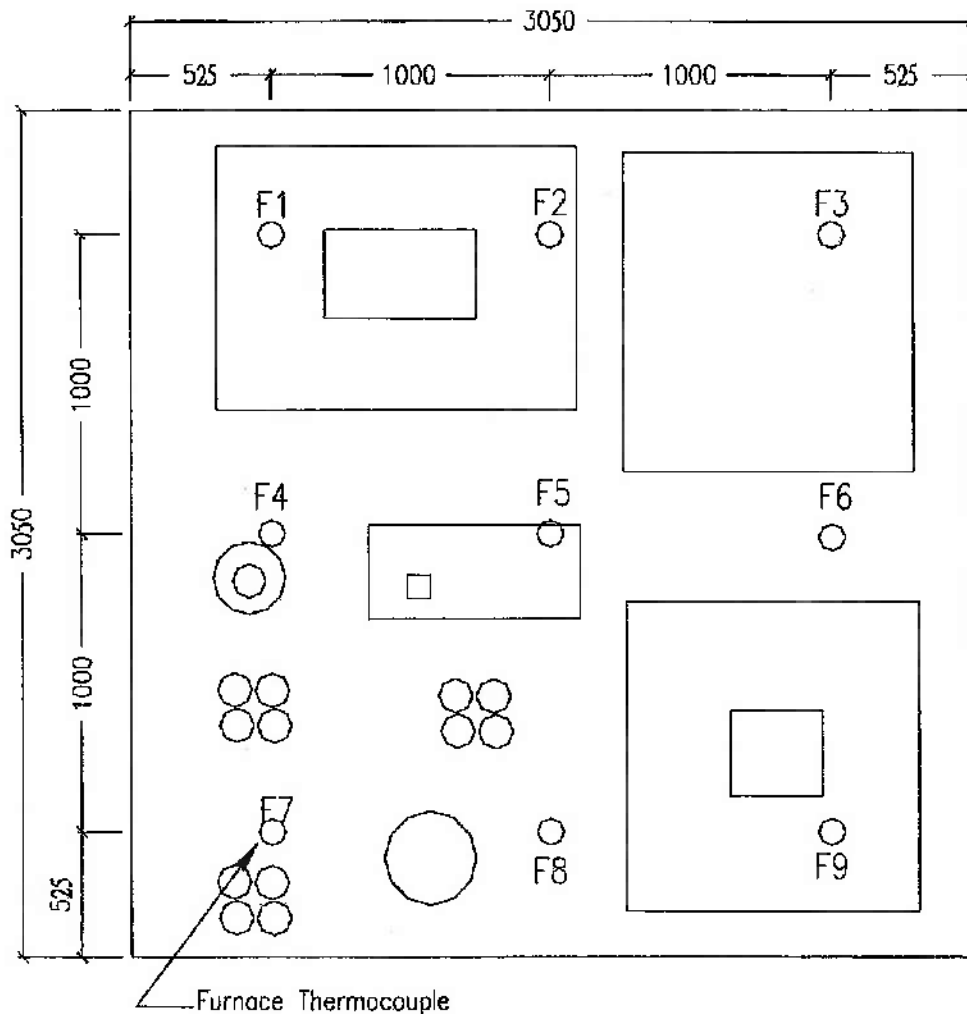
Figure 1 – Locations and reference numbers of furnace thermocouples.
(This figure is not to scale and all dimensions are in millimetres.)

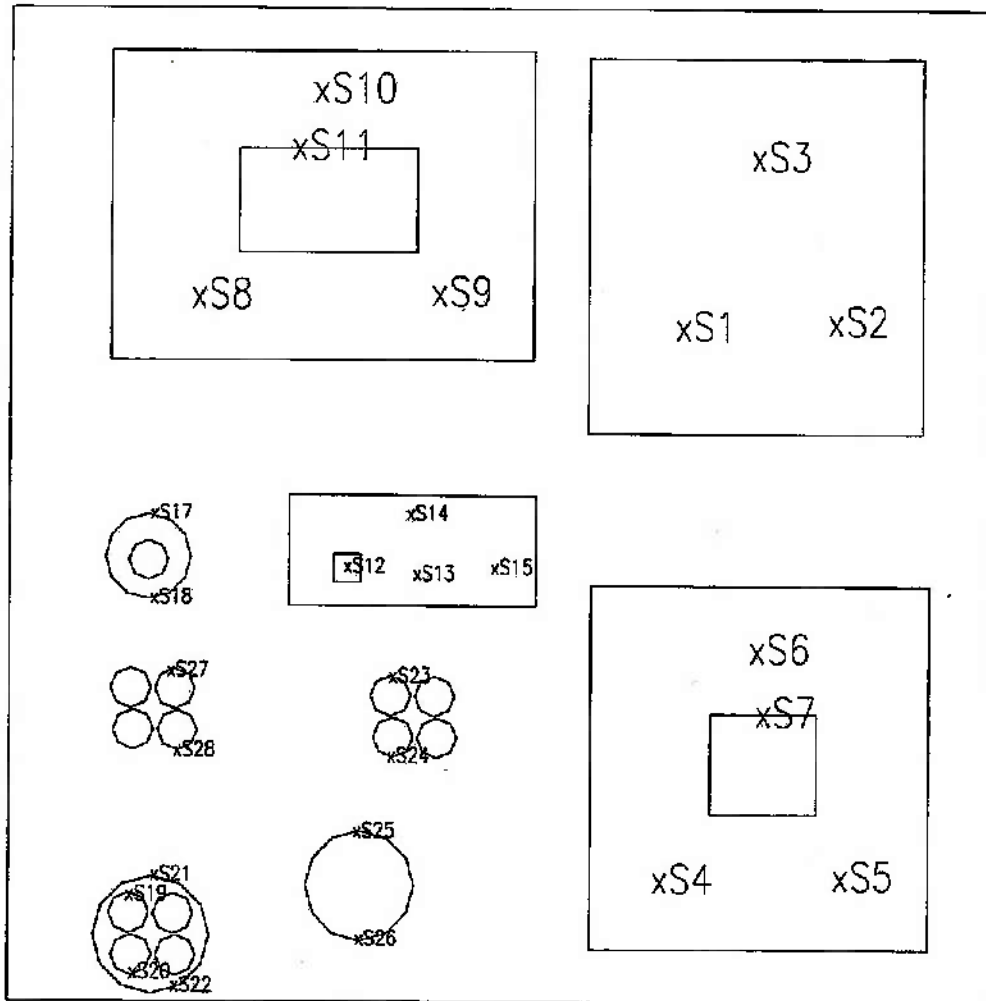
Figure 2 – Locations and reference number of thermocouples to monitor the temperature of unexposed surface of the specimens.

Note: Thermocouple S16 was fixed inside the socket box of specimen '15' for additional information only.

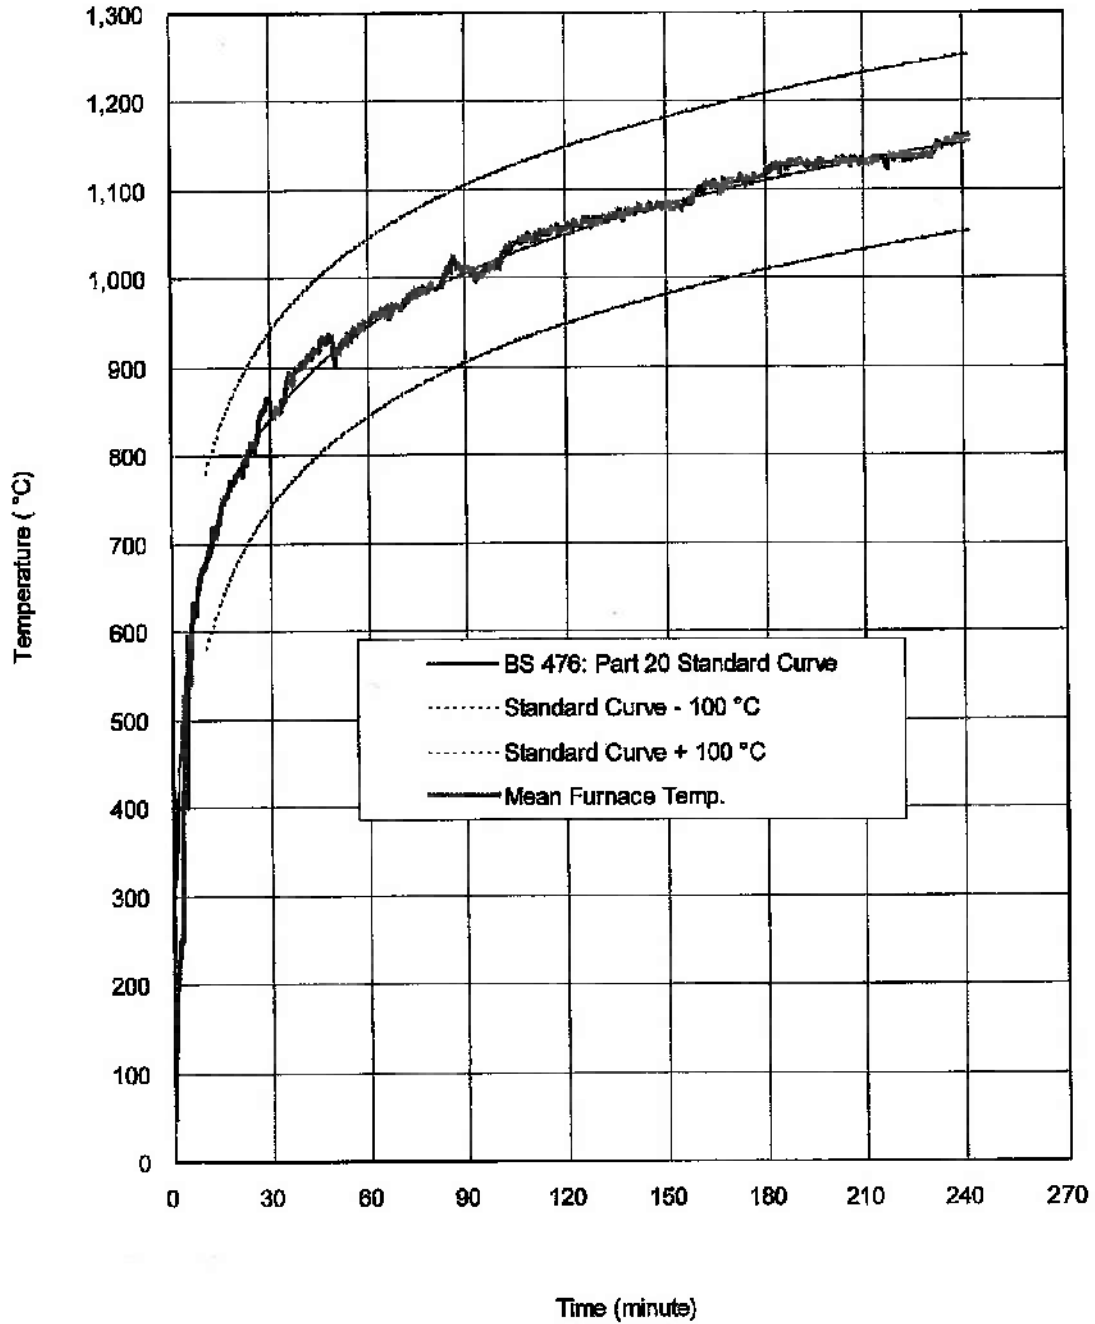
Figure 3 – Mean furnace temperature.

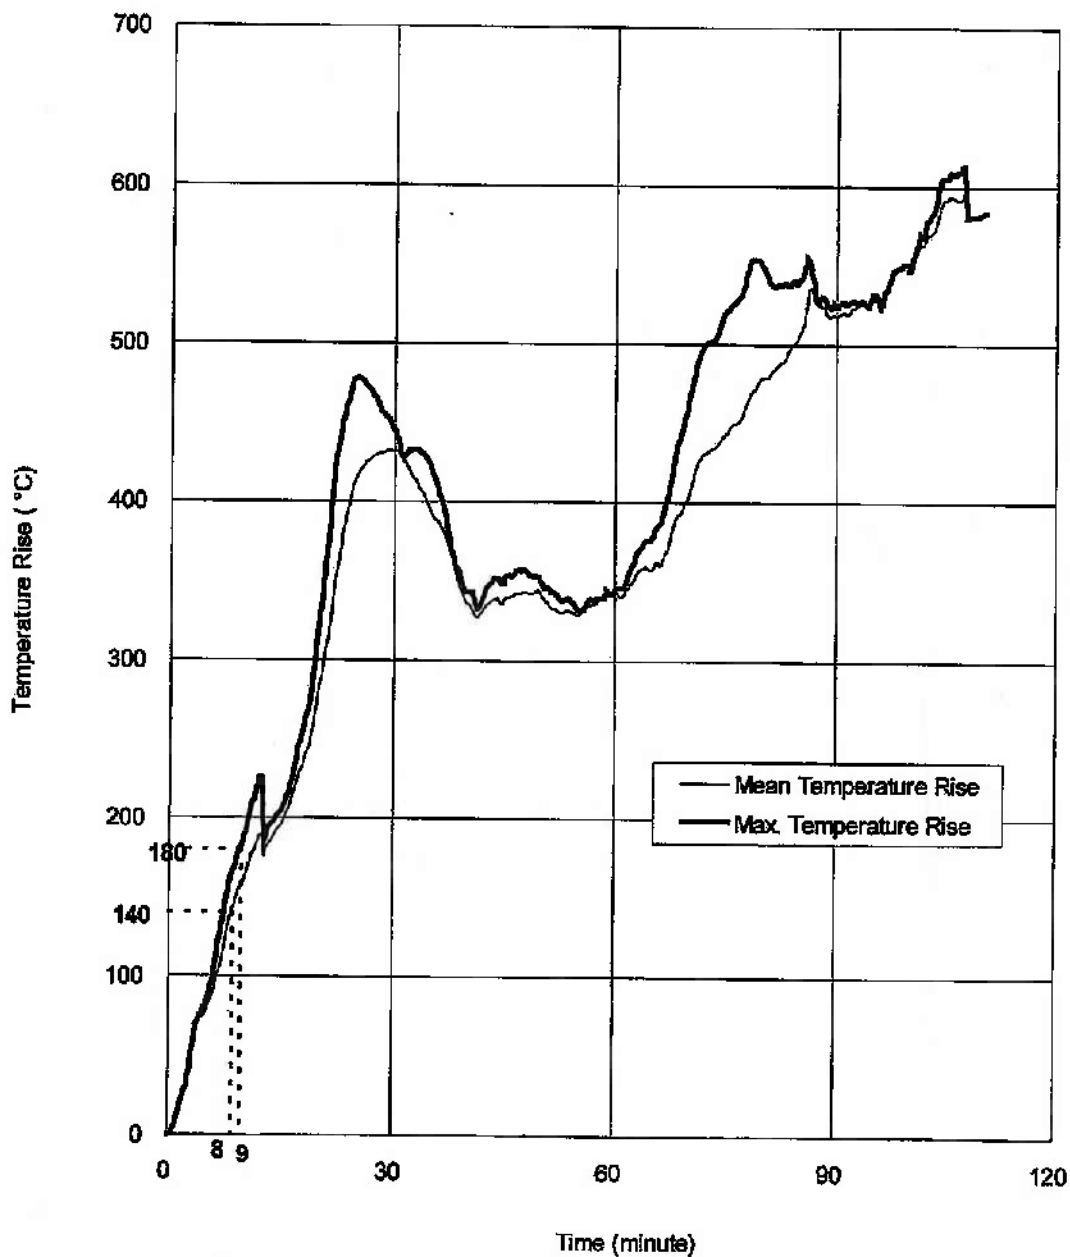
Figure 4 – Temperature rises of unexposed surface of specimen '12'.

Note: Thermocouples S1 – S3 malfunctioned after a heating period of 110 minutes.

Specimen '12' was comprised of Firestop Composite Sheets. The overall and exposed sizes of the Firestop Composite Sheets were 910 mm wide by 910 mm high by 3.8 mm thick. The Firestop Composite Sheets were joined together with M5 by 25 mm long screws at 250 mm nominal centres and fixed to L-angles with sizes of 50 mm by 50 mm by 5 mm thick at four sides. The L-angles was fixed the concrete with M6 by 54 mm long anchor bolts at 250 mm nominal centres. Stainless steel facing was faced at exposed side (refer to test sponsor's drawings).

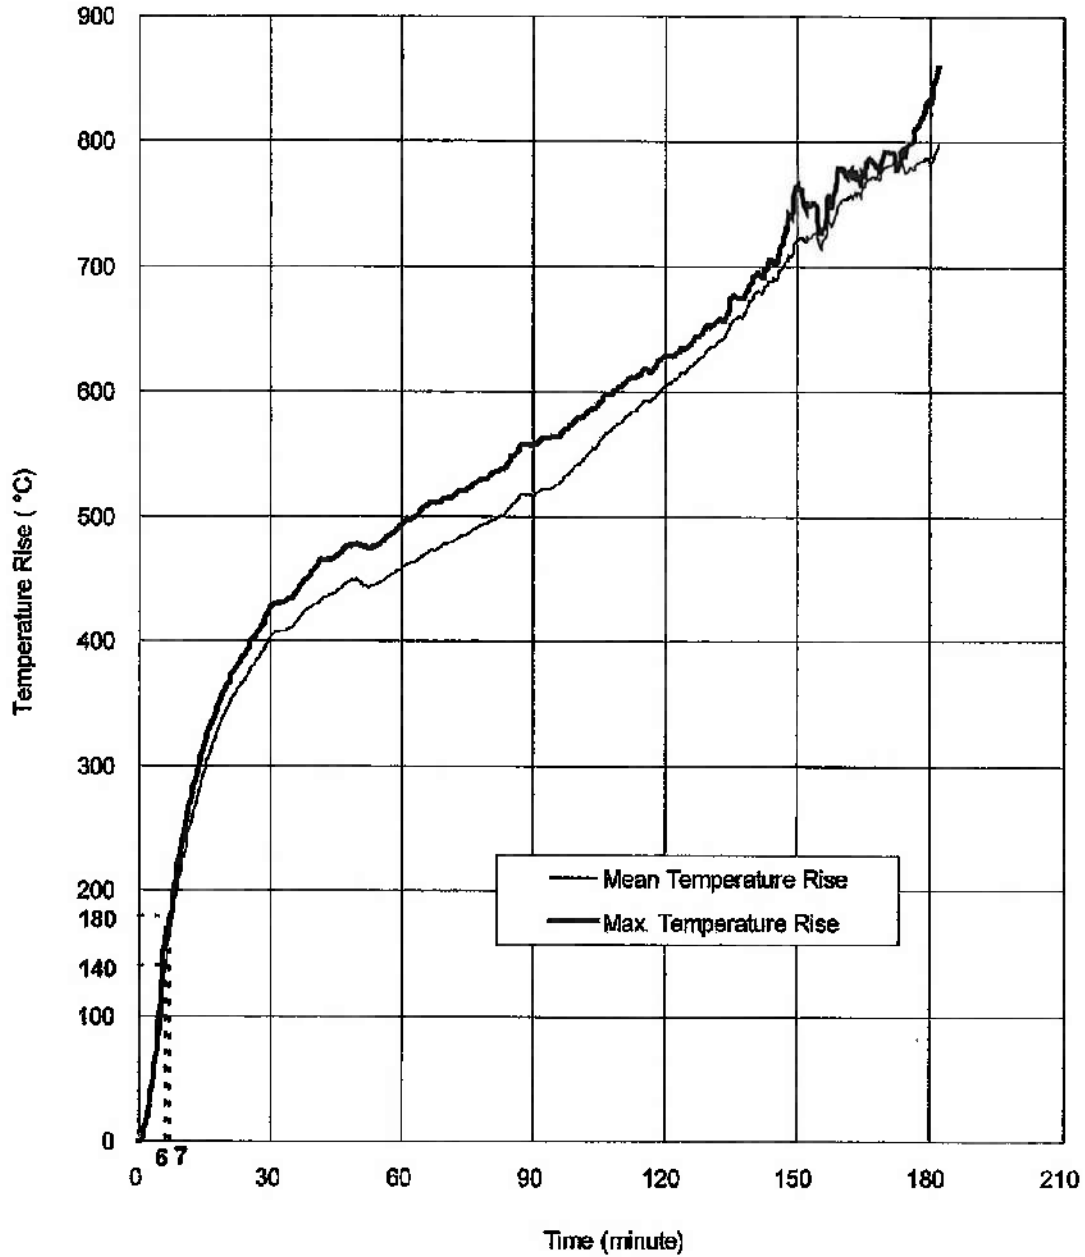
Figure 5 – Temperature rises of unexposed surface of specimen '13'.

Note: Thermocouples S4 - S7 malfunctioned after a heating period of 181 minutes.

Specimen '13' had overall dimensions 910 mm wide by 1,200 mm high by 3.8 mm thick with exposed area 810 mm wide by 1,100 mm high. It was comprised of Firestop Composite Sheets and a G.I. squared pipe. The G.I. squared pipe with sizes of 250 mm wide by 250 mm high by 1 mm thick was penetrated in the centre of specimen. The Firestop Composite Sheets were joined together with M5 by 25 mm long screws at 250 mm nominal centres and fixed to the concrete with M6 by 54 mm long anchor bolts at 250 mm nominal centres. Stainless steel facing was faced at unexposed side (refer to test sponsor's drawings).
