Hilti CFS-C EL Firestop Collar Endless

Submission Folder

FIRE RESISTANCE TEST IN ACCORDANCE WITH BS 476: PART 20: 1987
On 6 nos. of PVC Pipes and Conduits (Specimens '20', '22', '23', '24', '25' and '26')

Test Report No.: R16L28-1C

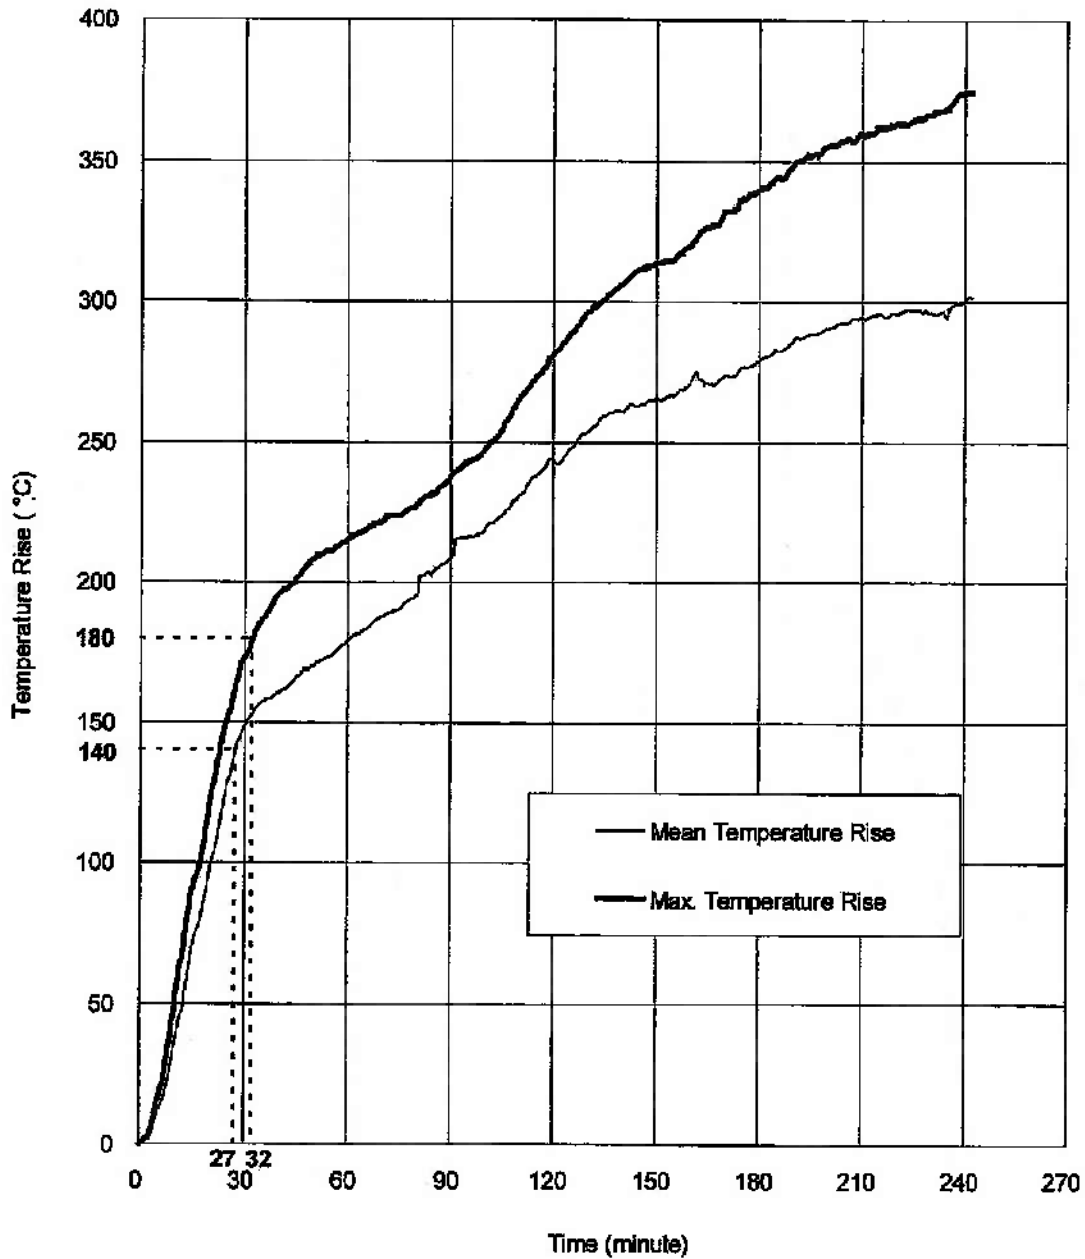
Figure 6 – Temperature rises of unexposed surface of specimen '14'.

Specimen '14' had overall dimensions of 1,010 mm wide by 910 mm high by 3.8 mm thick with clear opening area 900 mm wide by 810 mm high. It was comprised of two layers of Firestop Composite Sheets and a G.I. pipe. The G.I. pipe with sizes of 500 mm wide by 200 mm high by 1 mm thick was penetrated in the centre of specimen. The Firestop Composite Sheets were joined together with M5 by 25 mm long screws at 250 mm nominal centres and fixed to the concrete with M6 by 54 mm long anchor bolts at 250 mm nominal centres. Stainless steel facing was faced at both sides (refer to test sponsor's drawings).

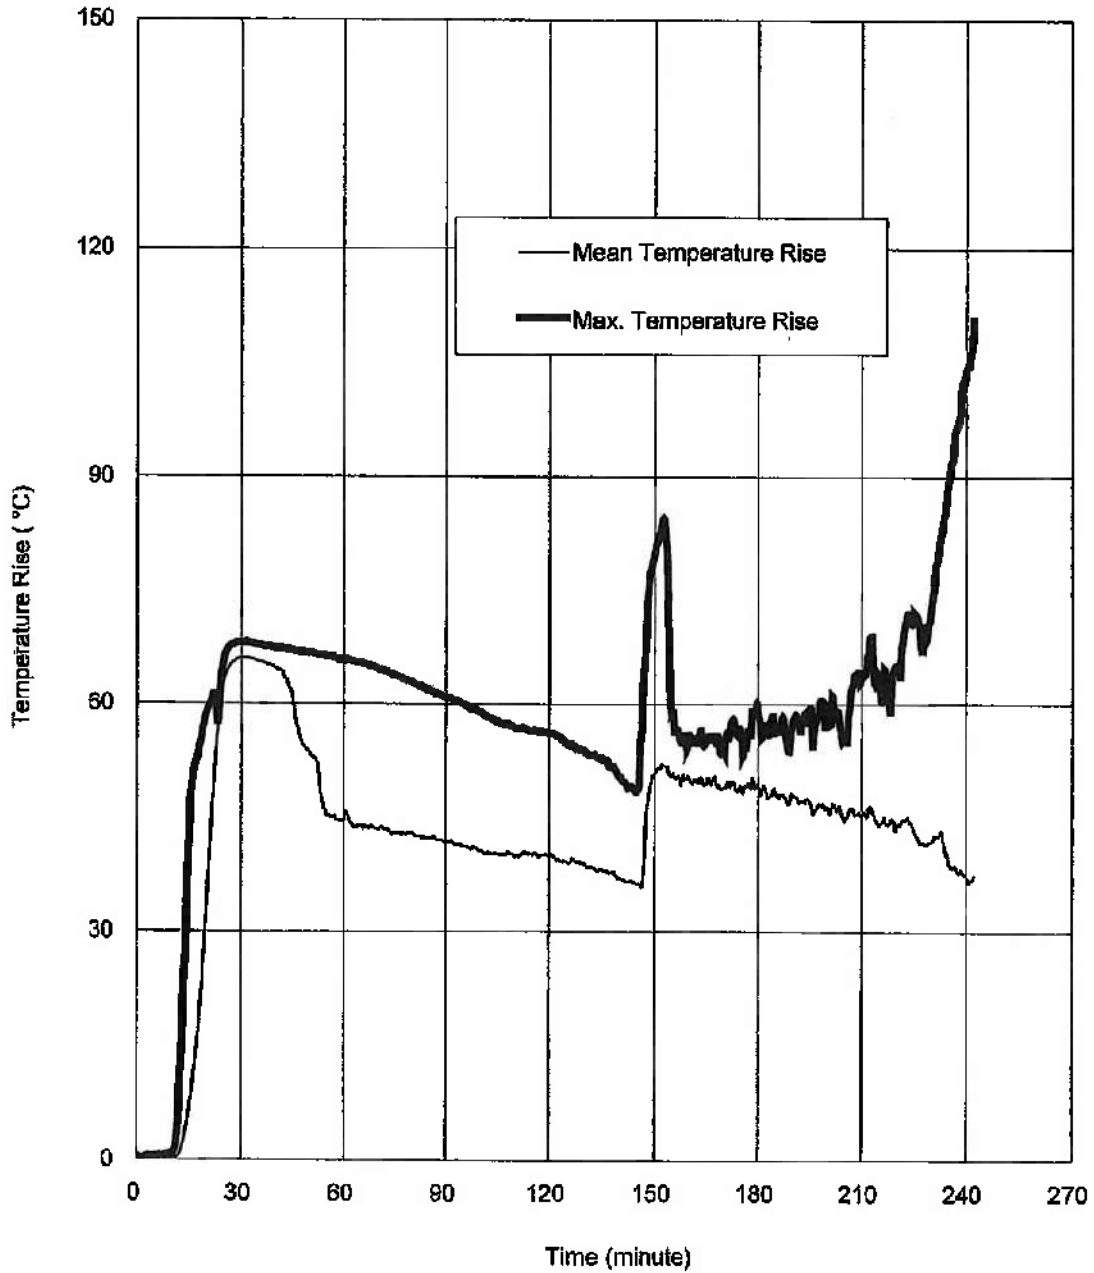
Figure 7 – Temperature rises of unexposed surface of specimen '15'.

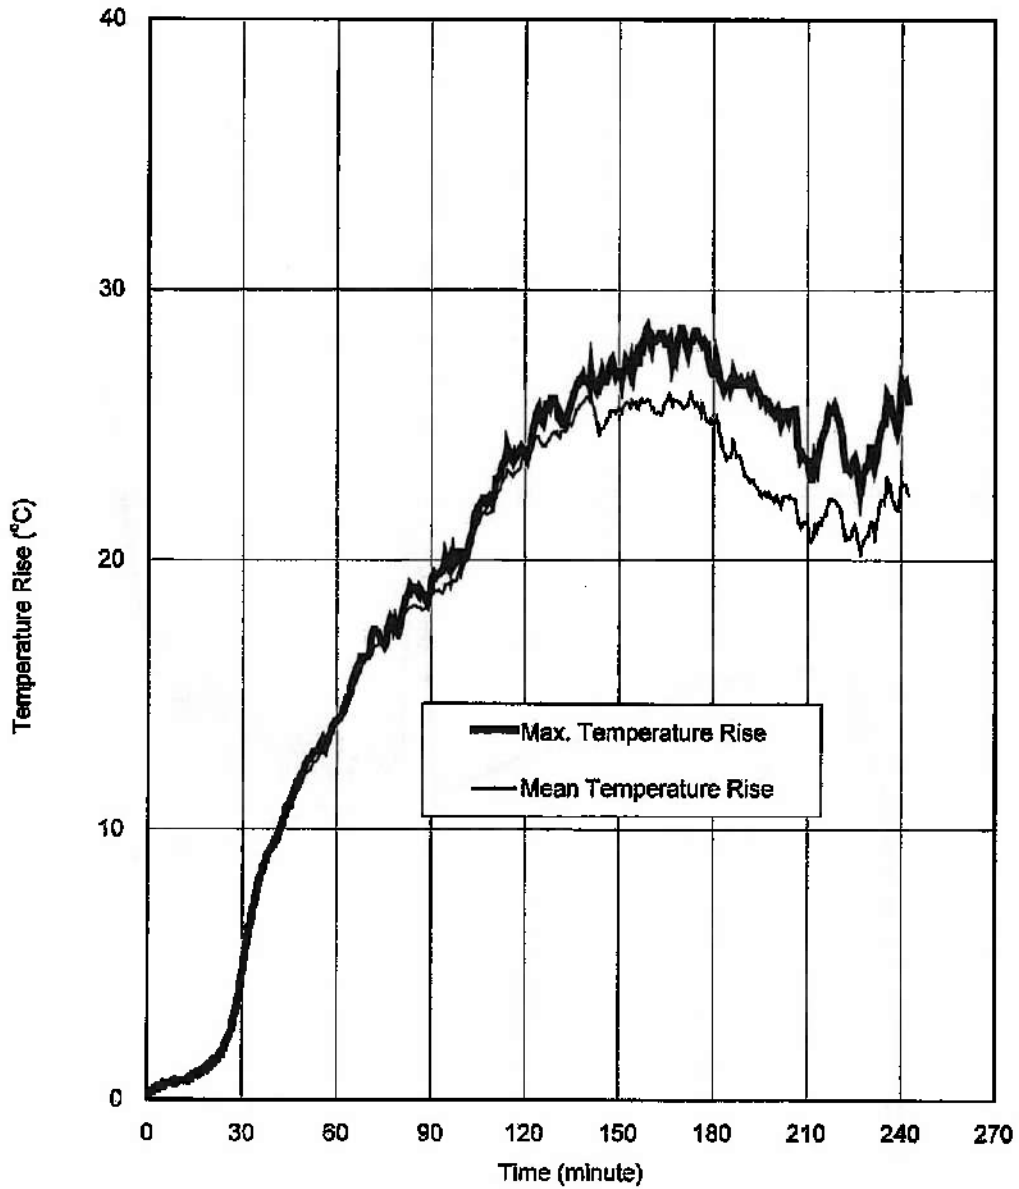
Figure 8 – Temperature rises of unexposed surface of specimen '16'.

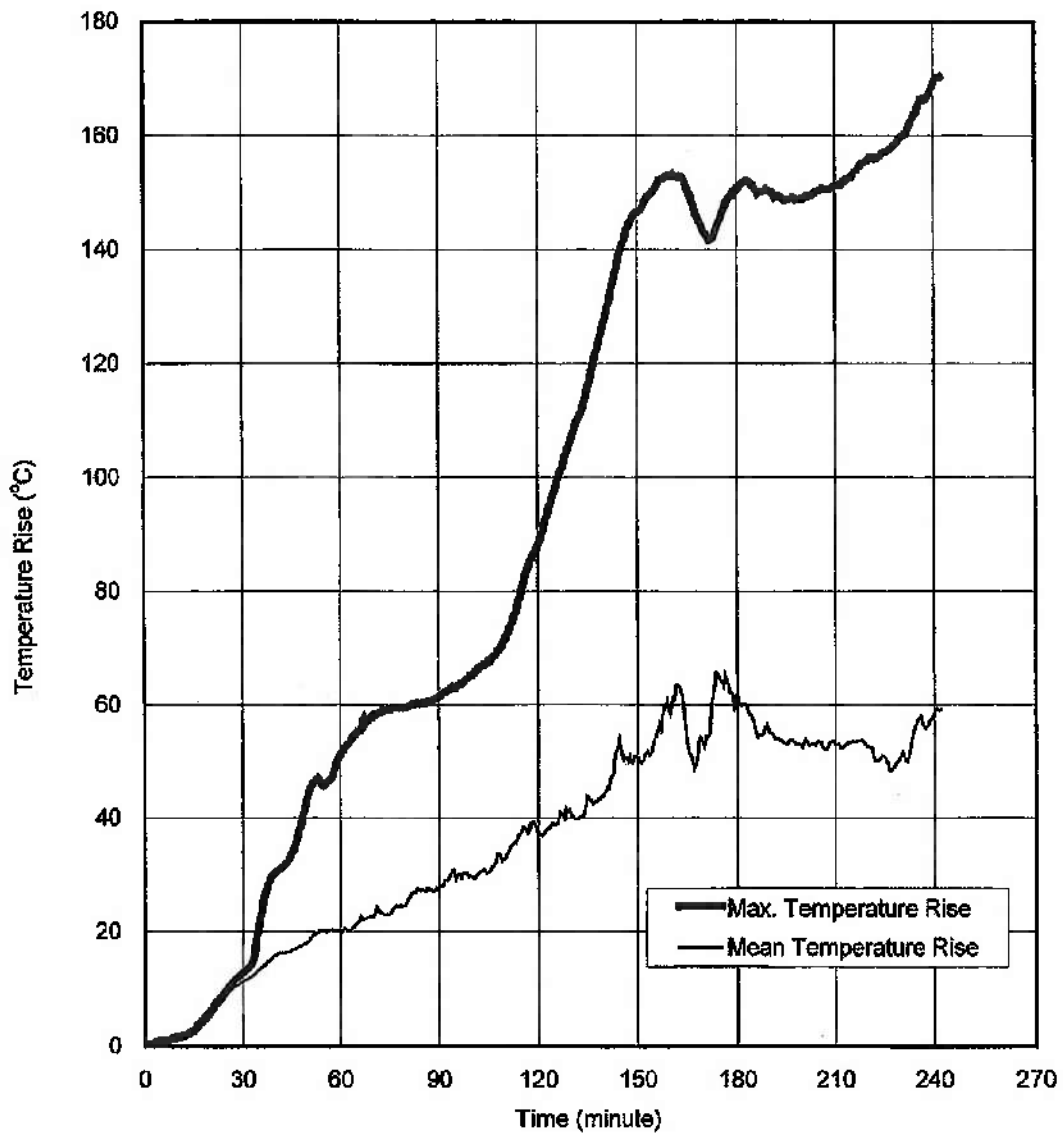
Figure 9 -- Temperature rises of unexposed surface of specimen '17'.

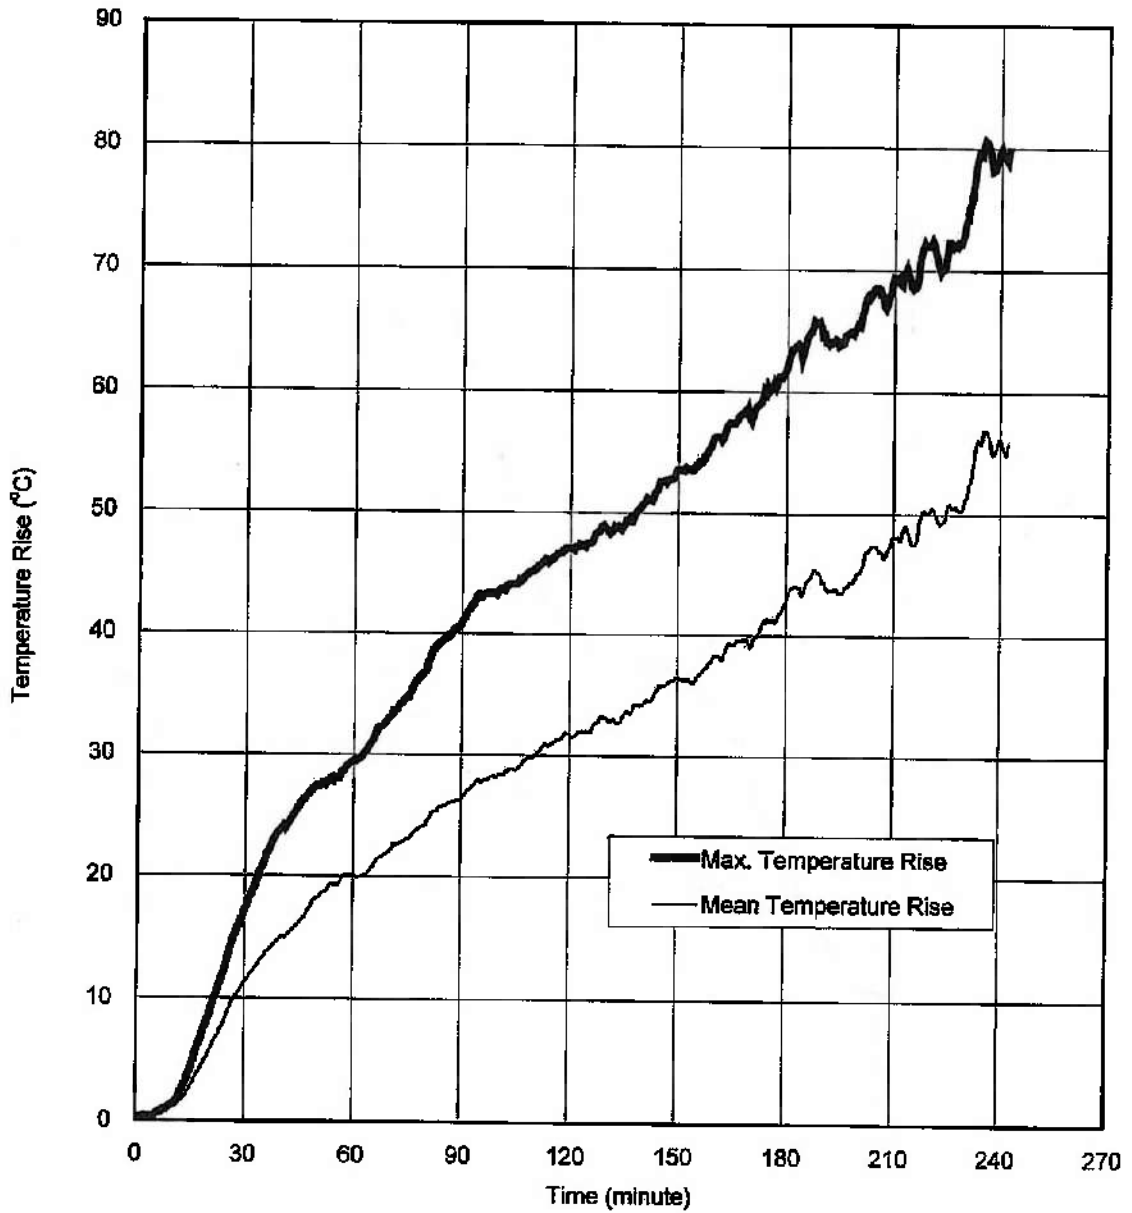
Figure 10 ~ Temperature rises of unexposed surface of specimen '18'.

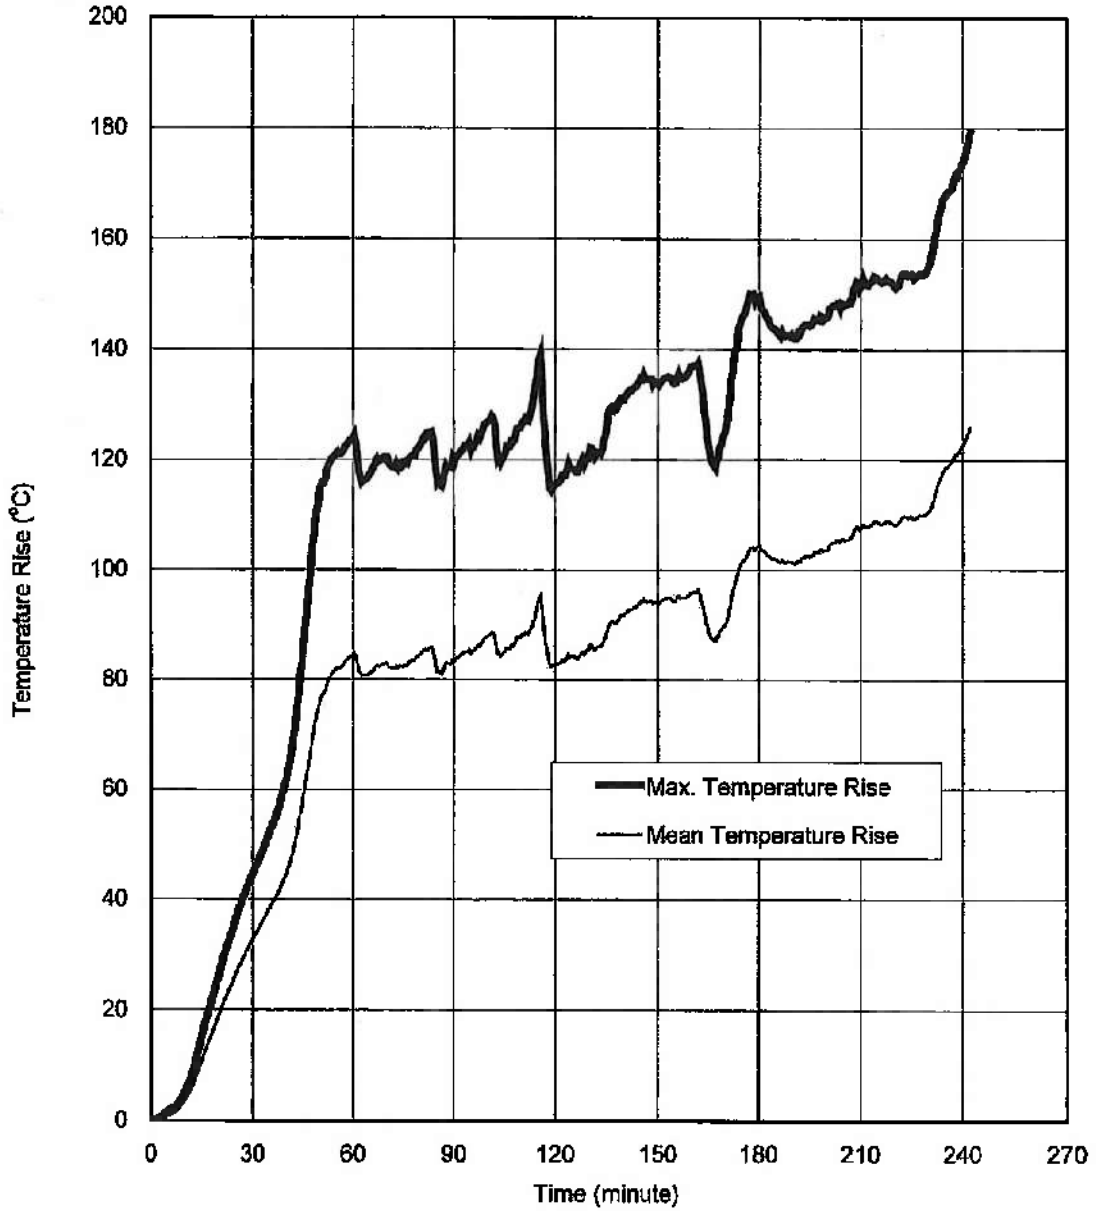
Figure 11 – Temperature rises of unexposed surface of specimen '19'.

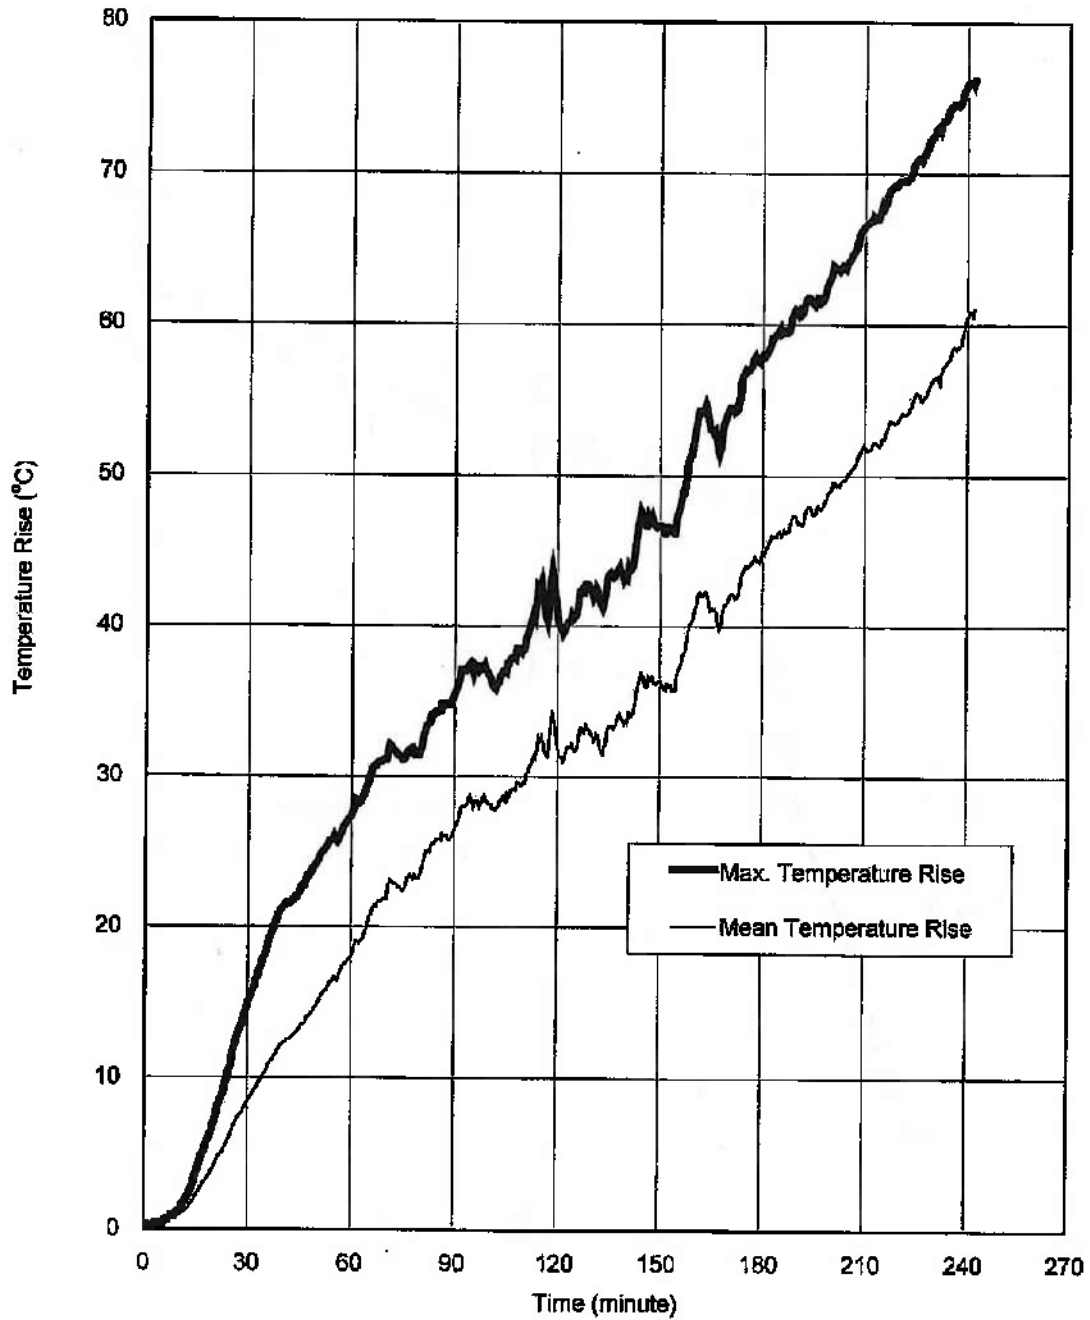
Figure 12 -- Temperature rises of unexposed surface of specimen '20'.

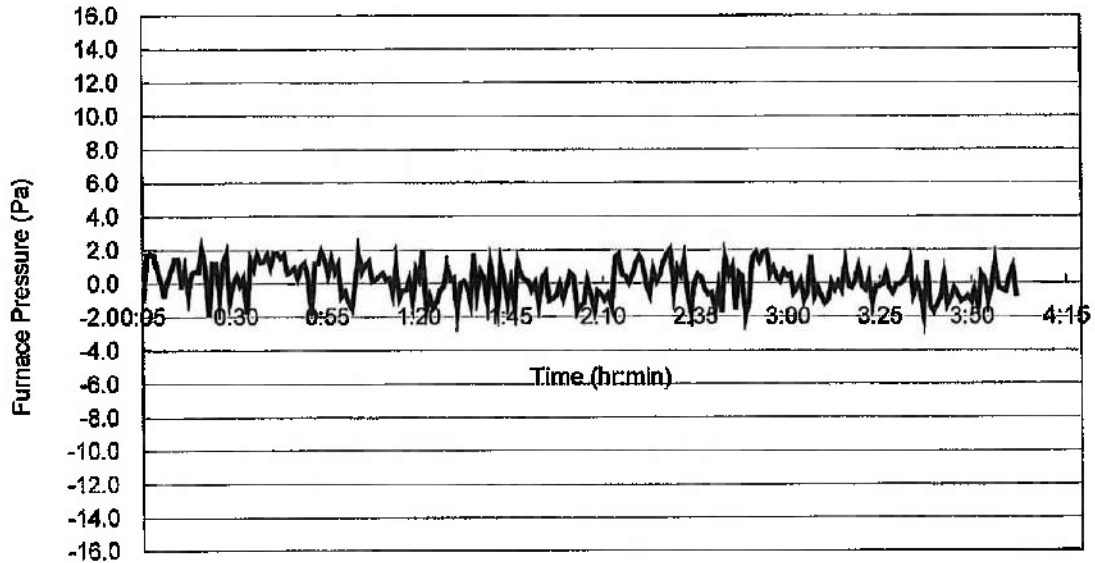
After the first 5 minutes of the test, the furnace pressure was maintained at 0 ± 2 Pa relative to atmosphere, at 1,000 mm from the notional floor level

Figure 13 – Furnace pressure.

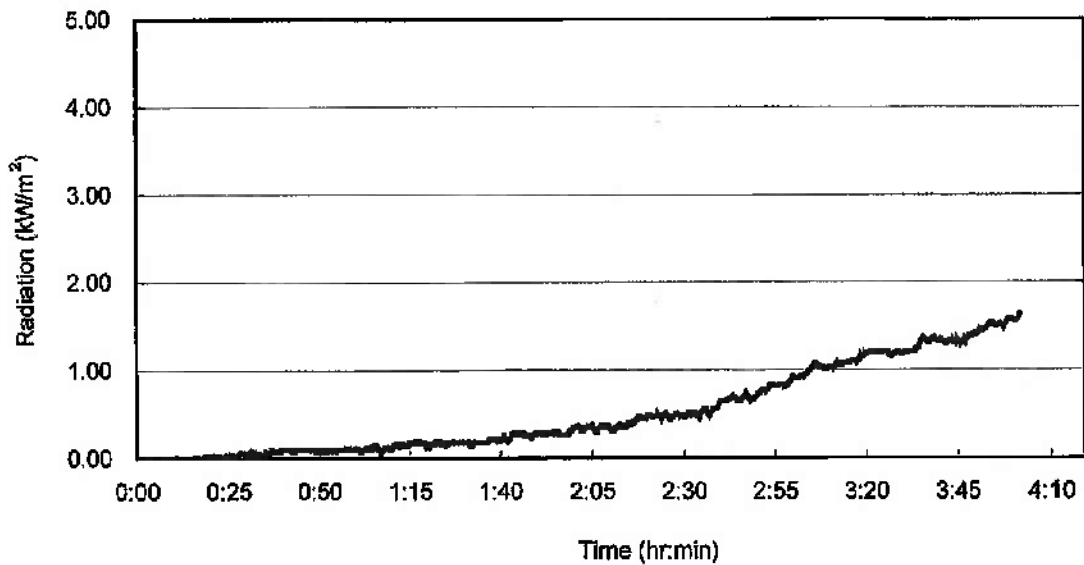
A radiometer placed at 3,000 mm away from the unexposed surface to measure the radiation of unexposed surface of specimens.

Figure 14 – Radiation.
